Performance of Structures in the Andaman and Nicobar Islands (India) during the December 2004 Great Sumatra Earthquake and Indian Ocean Tsunami

C.V.R. Murty,^{a)} M.EERI, Durgesh C. Rai,^{a)} M.EERI, Sudhir K. Jain,^{a)} M.EERI, Hemant B. Kaushik,^{a)} Goutam Mondal,^{a)} and Suresh R. Dash^{a)}

The damage sustained by buildings and structures in the Andaman and Nicobar islands area was due to earthquake shaking and/or giant tsunami waves. While damage on Little Andaman Island and all the Nicobar Islands was predominantly tsunami-related, damage on islands north of Little Andaman Island was primarily due to earthquake shaking even though tsunami waves and high tides were also a concern. In general, the building stock consists of a large number of traditional and non-engineered structures. Many traditional structures are made of wood, and they performed well under the intensity-VII earthquake shaking sustained along the islands. However, a number of new reinforced concrete (RC) structures suffered severe damage or even collapse. Also, extensive damage occurred to the coastal and harbor structures in the Andaman and Nicobar islands. [DOI: 10.1193/1.2206122]

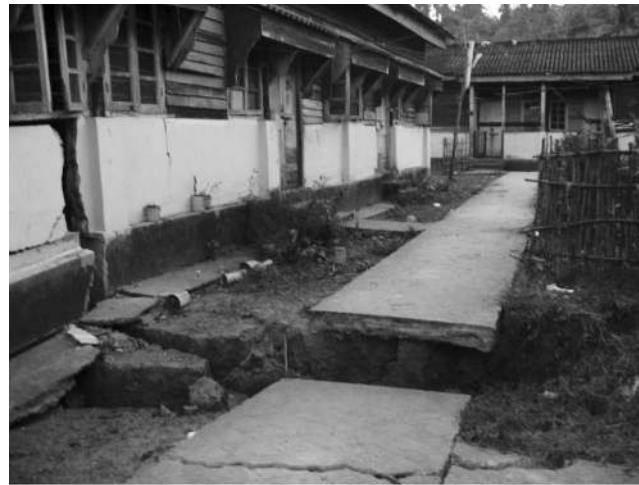
Amplification of ground motion coupled with liquefaction and lateral spreading of alluvial soil caused severe damage to the colony. Liquefaction in the form of sand boils was observed at different places. The ground shaking was so strong that people were not able to stand during the earthquake. Lateral spreading and other liquefaction-related phenomena were responsible for extensive damage to residential buildings (Figure 4) and health care facilities in the low-lying areas, especially in the vicinity of water bodies,

Figure 4. Damage to residential buildings: (a) severe damage to houses in the government residential area in Nimbudera village in Middle Andaman Island, where large ground motion and liquefaction were noted; and (b) at Mohanpur village in North Andaman Island, a single-story masonry building—despite having a light roof—sustained severe damage due to the lack of any earthquake-resistant features; the area around the building seems to have suffered significant amplification of the ground motion (photos: G. Mondal).

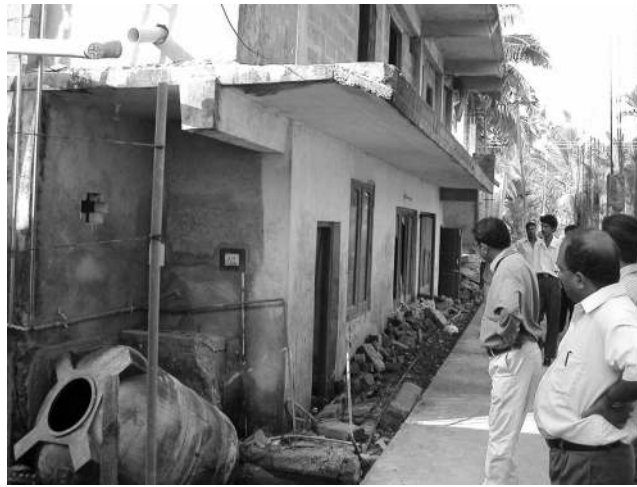
Figure 5. Settlement of RC buildings at Bamboo Flat near Port Blair (photo: H. Kaushik).

Settlement of buildings was observed at several locations in Port Blair, possibly due to foundation failure, erosion/settlement of underlying soil due to inundation of the region by tsunami waves, and liquefaction. In most cases, buildings near the sea settled in the earthquake, and signs of liquefaction, if any, were washed away when the tsunami struck. Two RC buildings and several shops in the shopping complex in Bamboo Flat near Port Blair settled, possibly due to liquefaction (Figure 5). Several buildings in the harbor area in Port Blair settled due to structural failure of some of the foundation piles. Figure 6a shows settlement of piles in the passenger terminal building at Haddo Wharf. Figure 6b shows severe damage at the junction of an RC pile and its pile cap supporting an RC building used for storage at Haddo Wharf.

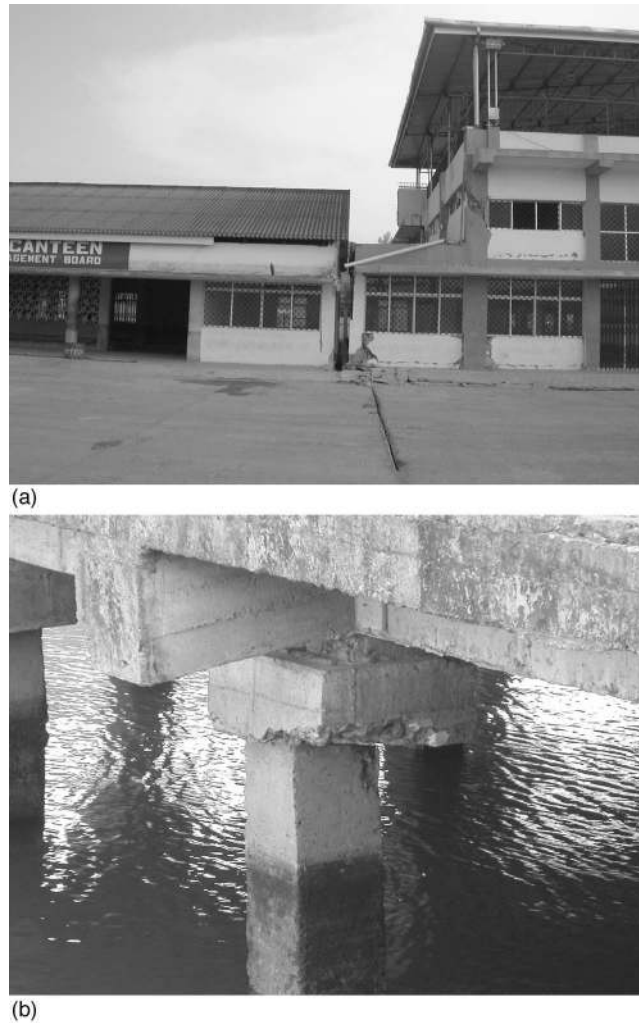
Figure 6. (a) Foundation (RC piles) settlement/failure resulted in settlement of the passenger terminal building at Haddo Wharf. (b) Dislocation of a pile cap in an RC storage building at Haddo Wharf (photos: H. Kaushik).

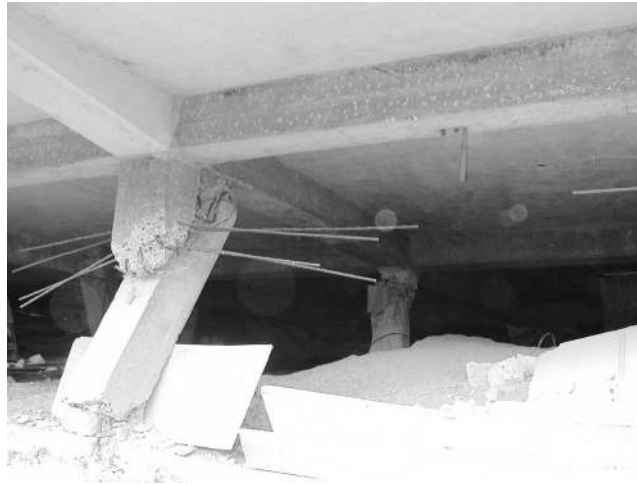
structures are made of wood, and they performed well under the intensity-VII earthquake shaking. However, a number of newly constructed RC structures suffered severe damage or even collapse due to shaking (Figure 7).

Figure 7. Buildings in Port Blair that were subjected to similar ground shaking intensity performed differently: a three-story RC-frame building collapsed in a brittle manner (photo: S. Jain).

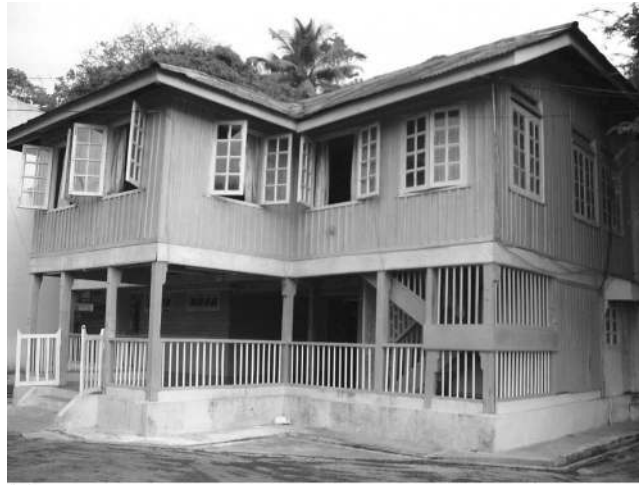
Figure 8. (a) In the Port Blair area and Rangat, wooden buildings with simple configurations performed well during ground shaking. (b) Some buildings with poor maintenance of the joinery between the wood frame and masonry plinth also performed well (photos: D. Rai).

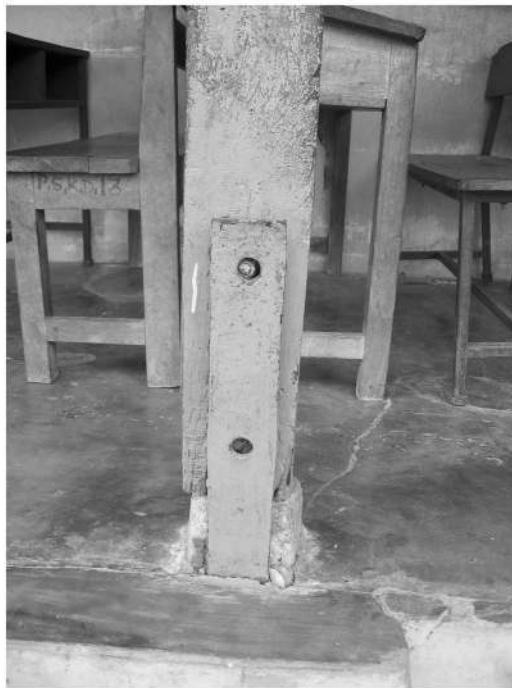
(b)

was observed to be poorly maintained (Figure 8b). However, even these structures performed well in contrast to the brittle unreinforced masonry buildings.

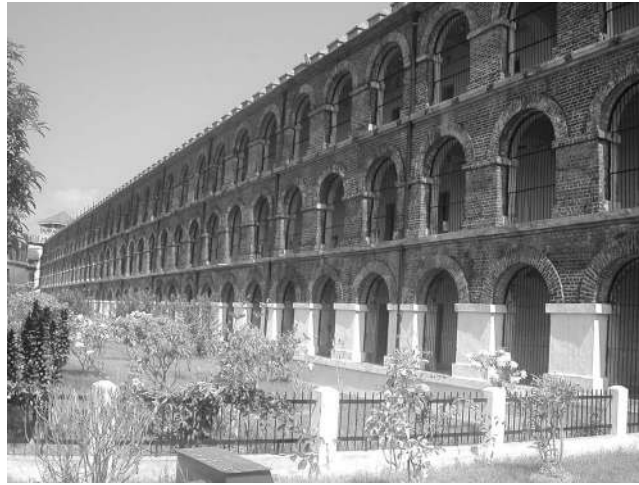
The A&N islands had several masonry buildings for residential and storage purposes, hospitals, schools, churches, jails, and so on before the severe earthquake of 26 June 1941 (magnitude 7.7). The famous masonry structure of the cellular jail was constructed in Port Blair over a period of ten years from 1896 to 1906 using solid brick masonry. The cellular jail was a huge structure, with a five-story central controlling tower and seven three-story wings containing 696 cells emanating from the central tower. The masonry used in the construction of the cellular jail was of a very high quality prevalent in India at that time (Figure 9).

Figure 9. Undamaged three-story masonry structure of the cellular jail (photo: S. Jain).

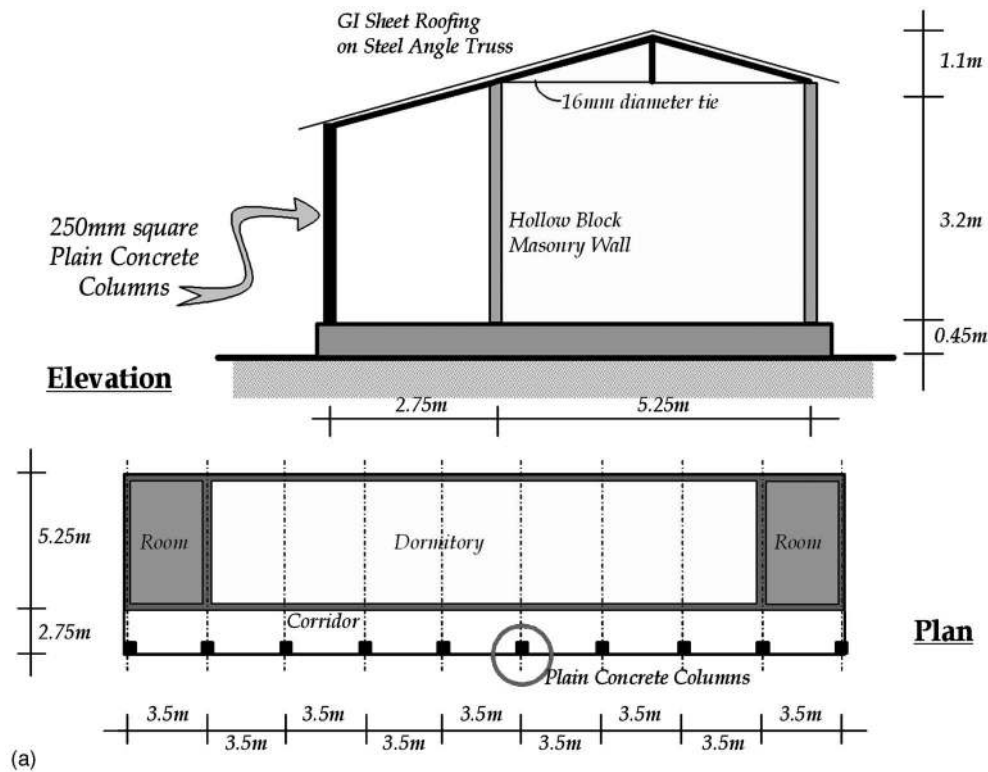
built as load-bearing masonry during 1982–83 by the Border Roads Organization (BRO). The typical barracks unit is 31.5 m long and 5.25 m wide. The ends have 3.5-m-wide rooms, but the rest of the building does not have cross walls. The superstructure is built of precast hollow cement blocks (twin cell with a 25-mm thick wall, 390 mm long \times 190 mm wide \times 190 mm high), while the foundation is in precast solid cement blocks. The veranda has 250-mm square plain concrete columns. The choice of plain concrete columns was made by the BRO to reduce the use of wood; this is different from the usual choice of wooden columns in the traditional structures of similar configuration in the island area. The roof consists of corrugated galvanized iron (GI) sheets supported on a steel angle truss. The bottom chord of the truss over the room is a 16-mm-diameter bar running across the room (Figure 11a). However, there is no such truss over the veranda area; the rafter rests directly on these plain concrete columns without any horizontal ties. A continuous lintel band is provided all around, but no vertical reinforcement is provided at wall corners and openings. However, two HYSD bars of 8 mm diameter are provided at every fourth course (\sim 800 mm centers) in the mortar bed joints. In general, these structures sustained horizontal cracks in the wall between the eave level and the lintel band along the full length of the building. Also, the plain concrete columns in the veranda area sustained cracks at the top and bottom. In one such building, such a column even collapsed (Figure 11b). Similar buildings with a larger number of cross walls performed better.

Figure 11. Military barracks in the Army land area at Campbell Bay in Great Nicobar Island: (a) typical dimensions of a unit, (b) collapse of a plain concrete corridor column (photo: S. Dash).

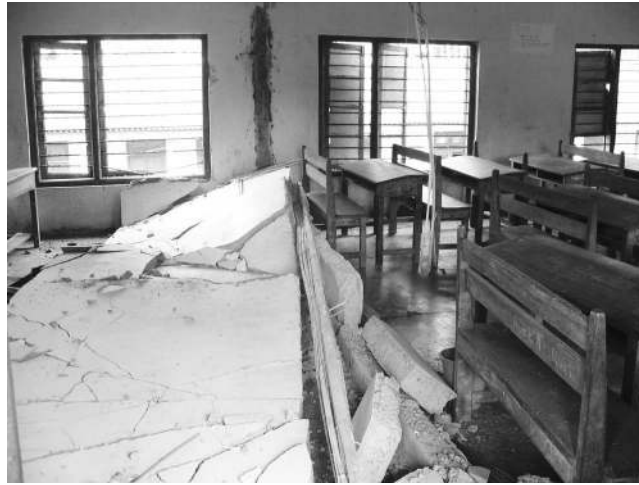
Figure 12. Slender masonry walls became dislodged because of out-of-plane instability and poor connection or no connection to the surrounding structural elements at the senior secondary school building in Adazigin, Middle Andaman Island (photo: D. Rai).

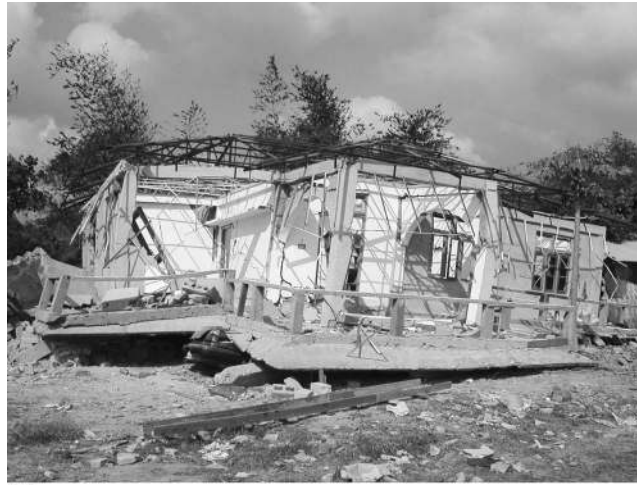
(a)

Figure 13. An RC-frame residential building that had been built on stilts near Port Blair collapsed because of severe seismic shaking in the Bamboo Flat area (photos: S. Jain).

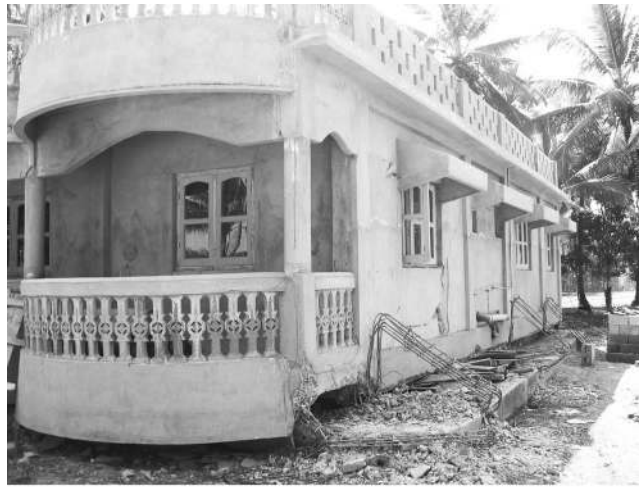
Figure 14. (a) Collapse of an open-story RC house at Rampur, near Mayabandar (photo: D. Rai). (b) Collapse of the RC bare frame of a three-story building under construction at Rangat, Middle Andaman Island (photo: G. Mondal).

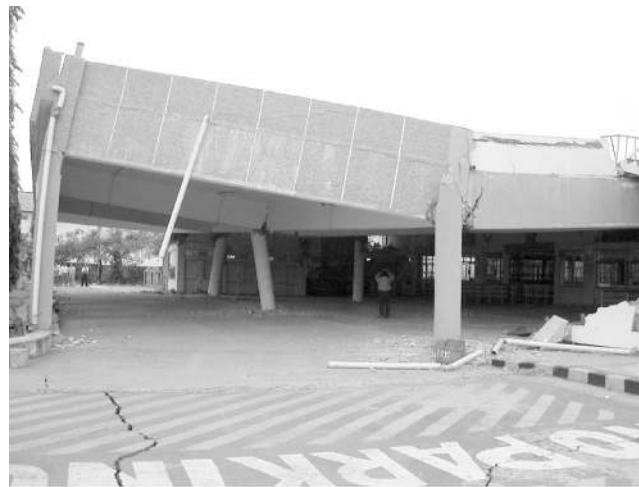
collapsing (Figure 15). In general, under earthquake shaking, RC-frame structures suffered various kinds of damage ranging from frame-infill separation and hinging at the ends of frame members to complete structural collapse.

Figure 15. (a) The passenger terminal building at Haddo Wharf collapsed due to the failure of brittle RC columns (photo: S. Jain). (b) Failure of RC columns and large flexural cracks in RC beams (photo: H. Kaushik).

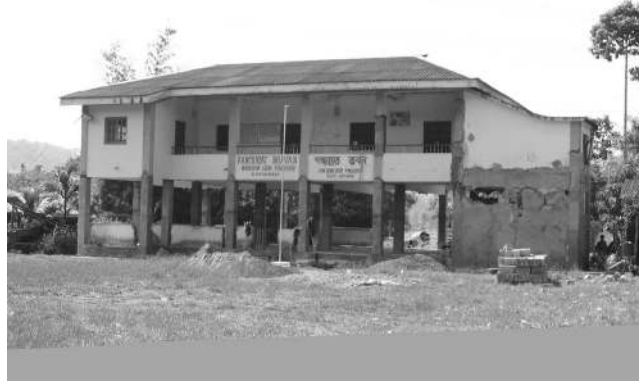
Figure 16. The Nabagram *panchayat bhavan* building was shaken by two earthquakes—on 14 September 2002 and 26 December 2004. Severe cracking and damage were observed in the soft first-story columns, and columns in the first story that were primarily damaged in the 2002 earthquake because of “missing” ties were now more severely damaged in the 2004 earthquake, even though they had apparently been “retrofitted” (photo: D. Rai).

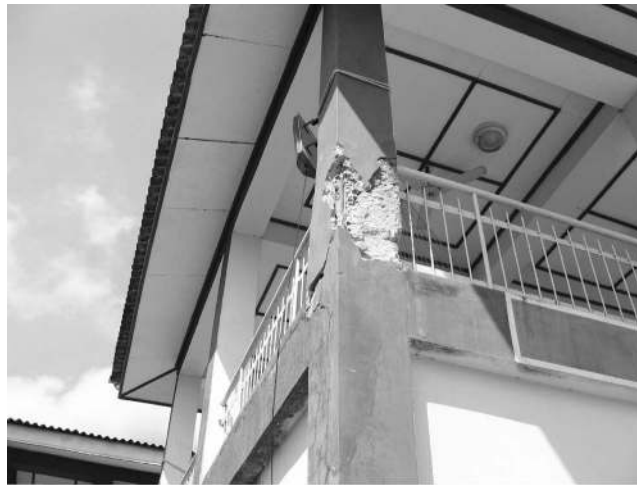
Figure 17. A two-story RC-frame Turtle Resort building in Shibpur, south of Diglipur, with an irregular structural configuration was also damaged during the 14 September 2002 $M_L=6.0$ earthquake in North Andaman Island, but only cosmetic repairs were undertaken after that event. This building then sustained damage during the 26 December 2004 earthquake in the same places. (a) Bottom of an upper-story column, and (b) top of a lower-story column (photos: D. Rai).

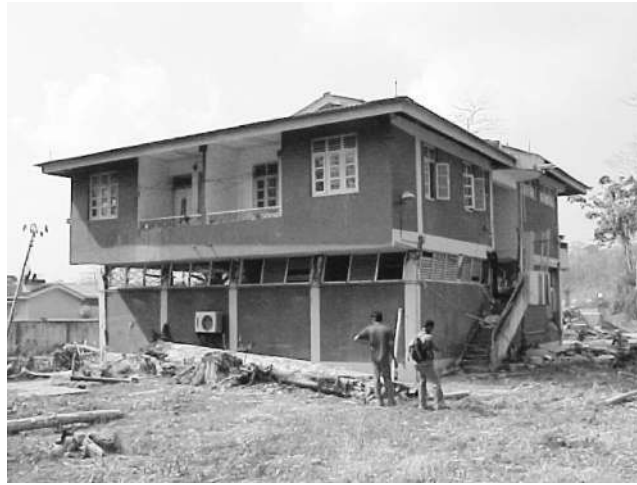
Figure 18. The BSNL telephone exchange building on higher ground at Hut Bay in Little Andaman Island was severely damaged due to earthquake shaking—it was twisted about the vertical axis during the shaking and sustained severe irreparable damage in its structural members. The structure was also flooded by the tsunami runup, and severe loss was sustained in non-structural elements and contents (photo: C. Murty).

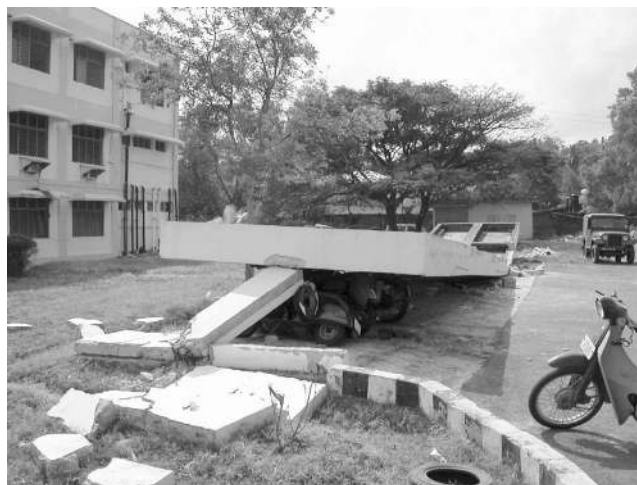
Figure 19. Collapse of a 2-m-high shelter for bicycles and motor scooters near the Port Management Board office complex in Port Blair (photo: S. Jain).

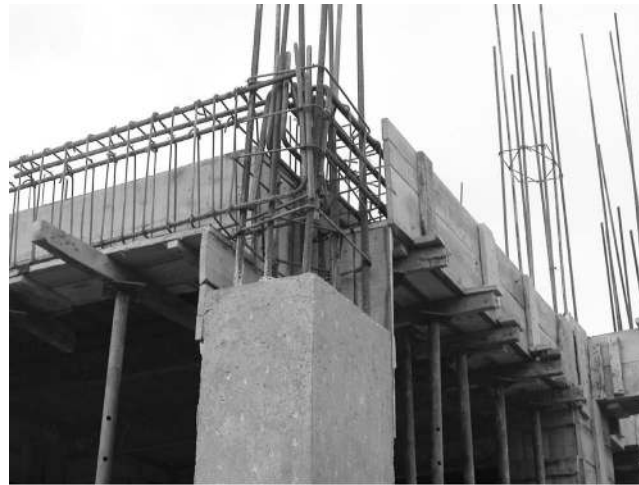
Figure 20. (a) The RC-frame construction under way for the new office complex near the marine jetty in Port Blair indicates poor compliance with the seismic requirements (photo: S. Jain). (b) Use of 90° hooks in RC-frame construction in Little Andaman Island (photo: C. Murty).

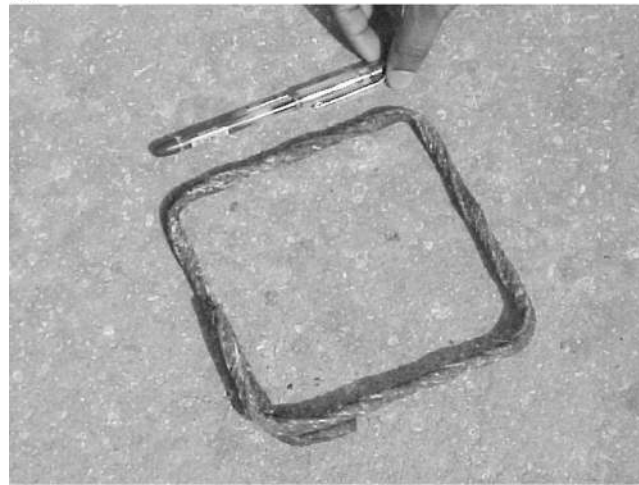
(b)

In general, these structures do not follow seismic design practices, even though the requisite seismic design codes exist in India. This is exemplified by the collapse of the single-story bicycle and motor scooter shelter because of the earthquake ground motion. The shelter’s stiff roof resting on very slender vertical columns indicates the lack of basic concepts like strong column/weak beam in the design practice (Figure 19). An approximate analysis of this collapsed RC shelter indicates that the peak ground acceleration in Port Blair during the earthquake was about 0.1 g (Kaushik and Jain 2006). Also, the construction practices in such structures lack quality control, as demonstrated by the incomplete hook lengths of the lateral ties in beams even though they are closely spaced (Figure 20a) and the use of 90° hooks in the beam and column ties (Figure 20b).

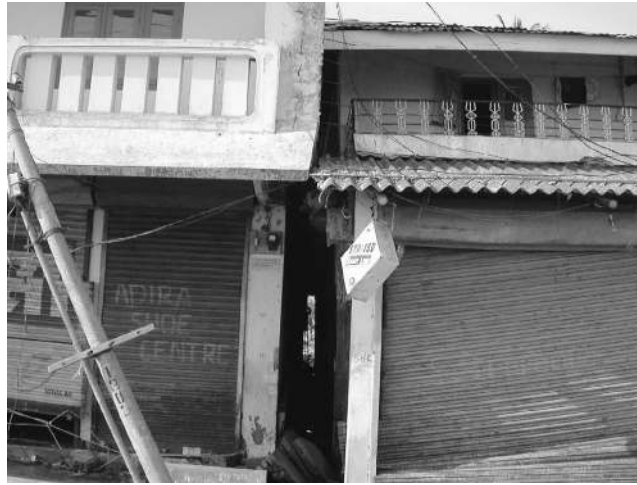
Because of the scarcity of open space, buildings in Port Blair are generally constructed very close to each other without a sufficient gap for large lateral deformations during strong ground shaking. Several buildings in the Bamboo Flat shopping complex (Figure 21) suffered substantial cracking and damage at the floor level in slabs, and in columns due to pounding with the adjacent buildings. The L-shaped three-story RC school building at Mohanpura in Port Blair, constructed in stages between 1986 and 1989, was damaged at the expansion joints in the building between different blocks.

Figure 21. Pounding occurred between closely constructed buildings in and around Port Blair. These buildings are in the Bamboo Flat shopping complex (photo: S. Jain).

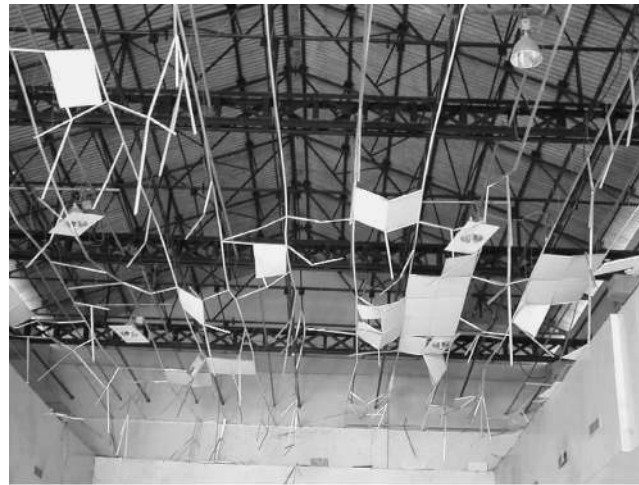
In the old dry dock in the marine jetty dry dock complex in Port Blair, several instances of nonstructural damage due to earthquake shaking were observed. The false ceiling of a fiberglass boat shed collapsed completely, disrupting the already-affected work in the shed (Figure 22a). Laterally unsupported masonry walls in shell structures used as a storage area in the dry dock complex collapsed due to the absence of any confining elements (Figure 22b).

Figure 22. (a) Collapsed false ceiling of the fiberglass boat shed in the marine jetty dry dock complex (photo: S. Jain). (b) Out-of-plane collapse of nonstructural masonry walls in a storage structure at the dry dock (photo: H. Kaushik).

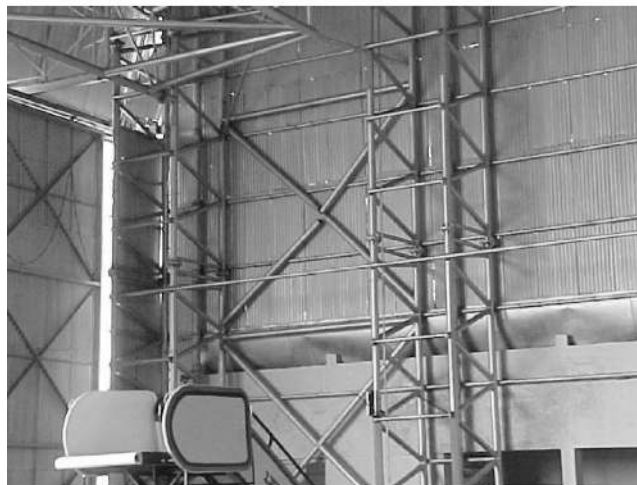
The steel tubular frame structure of the helicopter hangar at Car Nicobar Airport is $60\text{ m} \times 60\text{ m}$ in plan, with a gable roof 14 m tall at the eave level and 21.5 m at the crown. Eleven tubular trusses at 6-m spacing run along the transverse direction of the hangar. Each tubular truss has a $1.5\text{ m} \times 1.7\text{ m}$ rectangular plan configuration (1.7 m along the transverse direction of the hangar) with 160-mm -diameter pipes as corner elements, 100-mm -diameter pipes as inclined braces along the transverse direction, and 80-mm pipes as horizontal braces in the longitudinal direction of the truss. The 11 tubular gable trusses are connected to each other through steel pipes running in the longitudinal direction, except in the end bays, where three X-braces are provided over the 14-m vertical height between the end two trusses (Figure 23a). The braces are made by welding the two pipes directly to each other without any gusset plate arrangement; the fillet welding was performed along the curved interface surface. During the earthquake, the end X-braces failed along these curved weld lines (Figure 23b). The third-story braces even fell down to the ground.

Figure 23. Helicopter hangar at Car Nicobar Airport: (a) tubular truss configuration, and (b) weld failure at the X-braces in the end panels (photos: C. Murty).

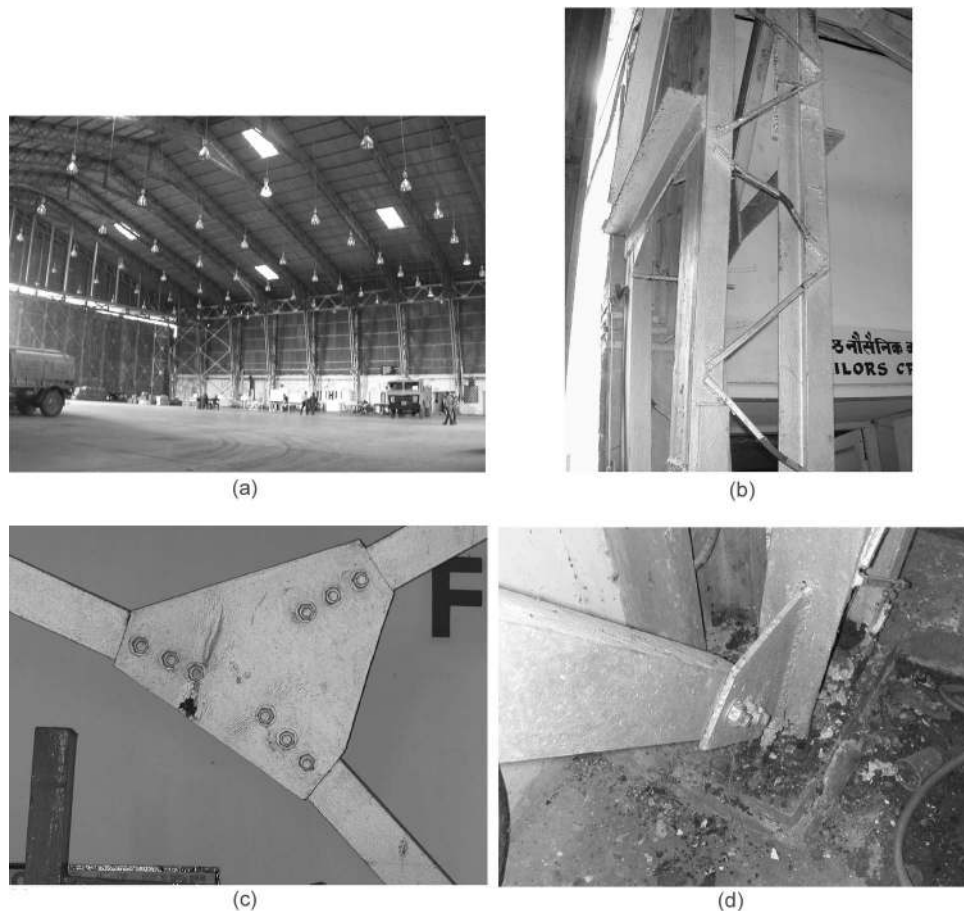
The hangar structure at Port Blair Airport, known as the INS Utkarsh Complex, also suffered slight damage due to ground shaking. The steel-frame structure, constructed in 1986, was $50\text{ m} \times 50\text{ m}$ in plan, with a roof truss 10 m tall at the eave level and 14 m at the crown (Figure 24a). Many of the braces in the steel columns, which were made of 15-mm square bars, were found to be buckled (Figure 24b). Several of the gusset plates connecting inclined brace members between adjacent columns buckled because of non-concurrent members meeting at the plate (Figure 24c). Severe corrosion was observed at the junction of the base plate and columns (Figure 24d).

Figure 24. INS hangar at Port Blair Airport: (a) truss configuration, (b) buckling of braces in steel columns (photos: H. Kaushik), (c) buckling of gusset plates connecting nonconcurrent braces between adjacent columns, and (d) severe corrosion at the junction of the base plate and column at the ground level (photos: S. Jain).

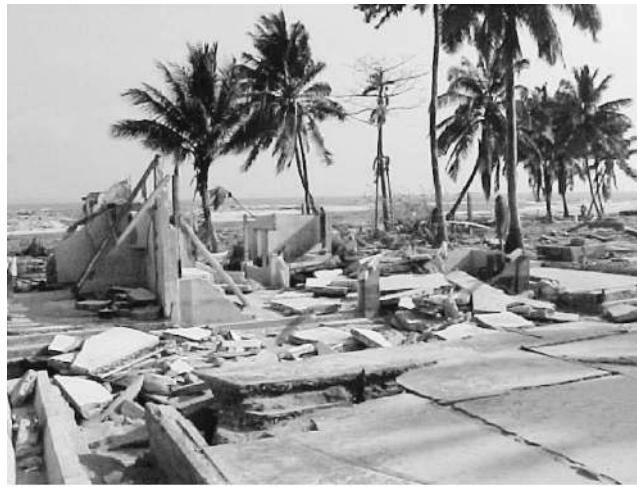
The giant tsunami waves caused severe destruction in the coastal areas of the southern islands. A large number of buildings constructed right on the coast were washed away. Complete devastation of the military residential colony south of Malacca on the east coast of Car Nicobar Island and of the built environment on the east coast of Hut Bay in Little Andaman Island was observed. The non-engineered (Figure 25a) as well as

Figure 25. (a) General destruction of non-engineered structures that resisted the giant tsunami waves in the fishermen's colony (Machchi Dera area) at Hut Bay in Little Andaman Island (photo: C. Murty). (b) Three-story RC-frame building with many masonry infill interior walls located right at the shore adjacent to the fishermen's colony at Hut Bay in Little Andaman Island; this building sustained no apparent structural damage despite lateral pressure from the tsunami (photo: S. Dash).

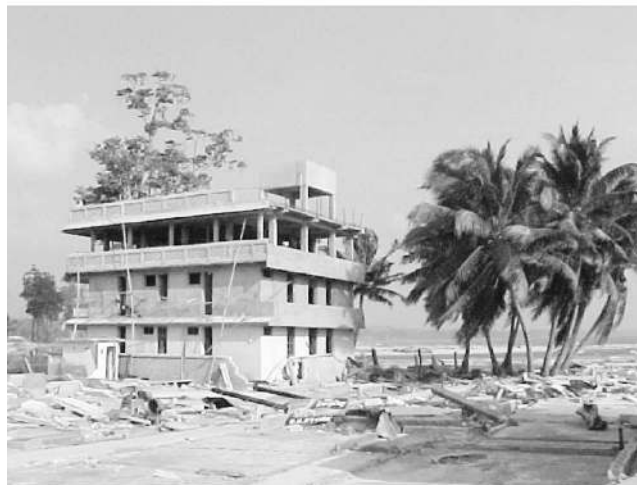
(b)

engineered RC structures performed poorly during the tsunami. However, an occasional well-designed RC structure can be seen standing even in the tsunami-devastated areas (Figure 25b). In general, flat lands adjoining the coast were the hardest hit. Structures that thronged by the shore were subjected to positive water pressure when the giant wave arrived and suction pressure when the wave receded. This pressure loading due to the tsunami was rarely resisted by a building on the ocean front without any damage. In the best cases, the frame of the RC-frame infilled building was intact, while the infills were pushed out of plane (Figure 26a); presumably, the RC frames in these buildings were well designed and constructed. A little further from the coast, other RC-frame buildings

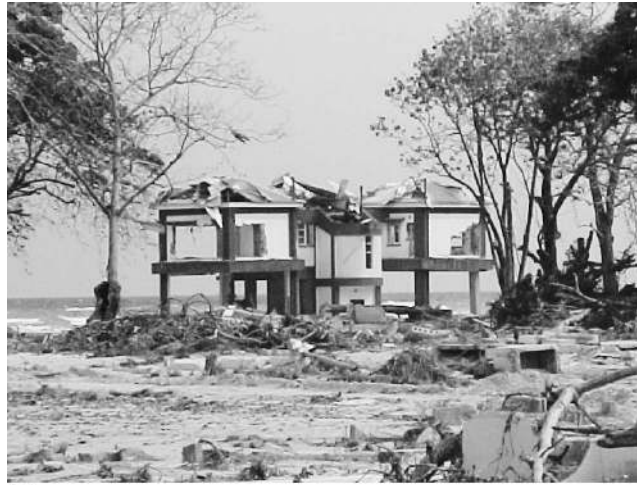
Figure 26. (a) Two-story RC-frame shorefront building with masonry infills in the military residential area in Car Nicobar Island. It was inundated but resisted the wave effects. Even though the building frame survived the wave effects, the great pressure sucked away the masonry infills, the occupants, and the contents. (b) Two-story RC-frame building with masonry infills about 300 m from the shore at Hut Bay in Little Andaman Island. The first story of this Andaman & Lakshadweep Harbour Works residential facility was submerged. It sustained severe structural damage in the first story due to lateral pressure of the tsunami and could not save the lives of people in the lower story (photos: C. Murty).

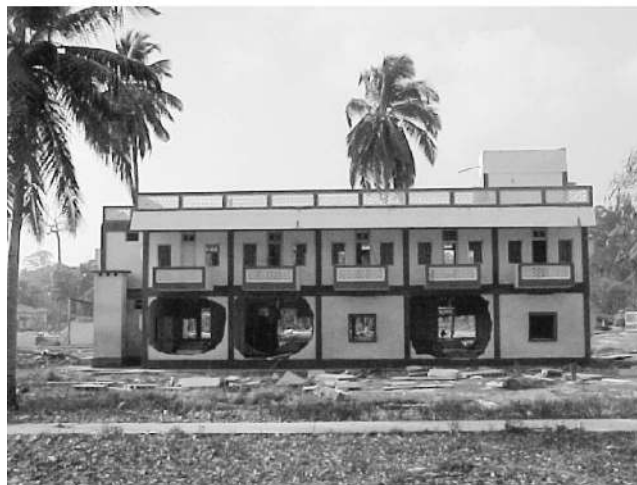
(b)

with masonry infills sustained severe damage only in the first story, owing to the punching out of the infills by the large lateral pressure of the tsunami (Figure 26b). In cases where a number of buildings were built in a row normal to the coast, the giant waves destroyed the structures toward the coast; buildings in the rear of such a row managed to survive because they were shielded from the giant wave by buildings in the front (Figure 27). In all, the number of surviving buildings at the shoreline of islands like Little Andaman and Car Nicobar is only a very small fraction of the total number of houses. Many structures that are seemingly standing are severely damaged or almost destroyed, with their basic structural safety in question due to scouring of the soil from underneath the foundation (Figure 28).

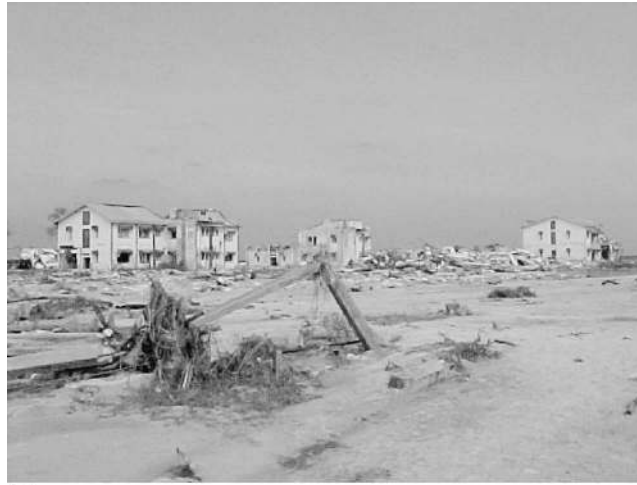
Figure 27. Military residential area in Car Nicobar Island: (a) buildings in a row normal to the shore show progressively increasing damage toward the coast, and (b) in large shorefront structures, the seaward section was severely damaged while the back side was relatively undamaged (photos: S. Dash).

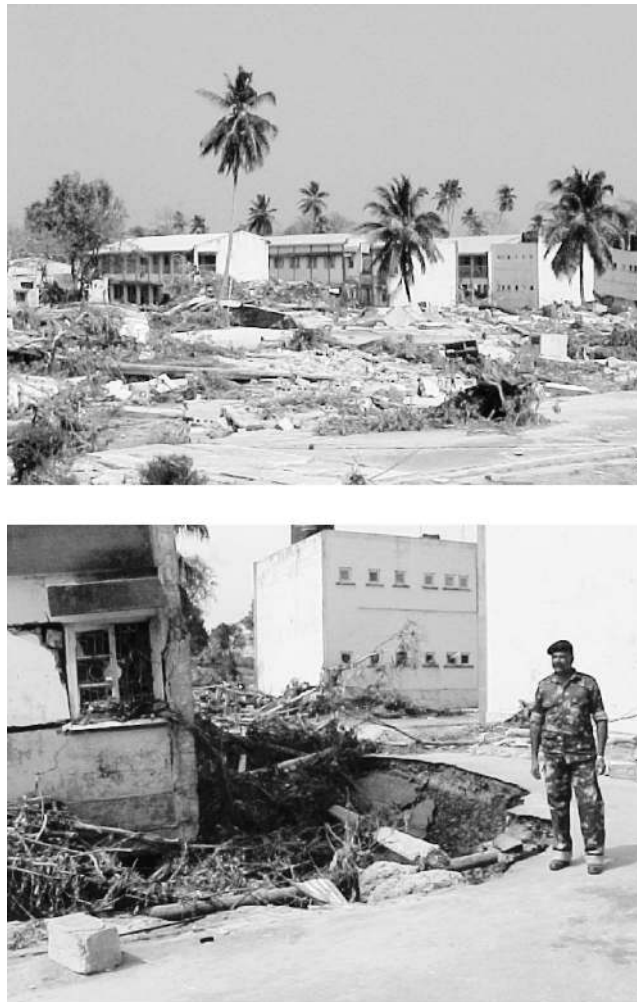
Figure 28. These buildings at the Air Force Colony in Car Nicobar Island are apparently standing after the tsunami, but their foundations have been scoured away (photos: C. Murty).

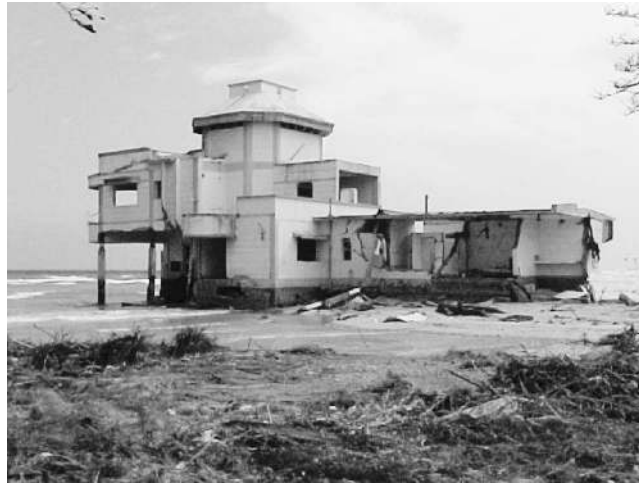
Figure 29. This RC-frame MES inspection bungalow now stands in waters at the Air Force Colony south of Malacca on the east coast of Car Nicobar Island (photo: C. Murty).

pressing view and tell the story of the brute force of the waves. The Military Engineering Service (MES) inspection bungalow at the Air Force Colony on this island was situated about 100 m from the seashore. Due to the eastward tilting of the Burma microplate on which the A&N islands are located and the subsidence of the eastern coast of the A&N islands, the shore at the Air Force Colony on Car Nicobar Island subsided by about 1.5 m. Owing to this, the water level of the sea in this area was reported to have risen by about 1.5 m after the earthquake. As a consequence of this ground shaking, subsidence, and tsunami, this building sustained severe structural damage and is in a state of incipient collapse, with the seawater lashing at its column footings (Figure 29).

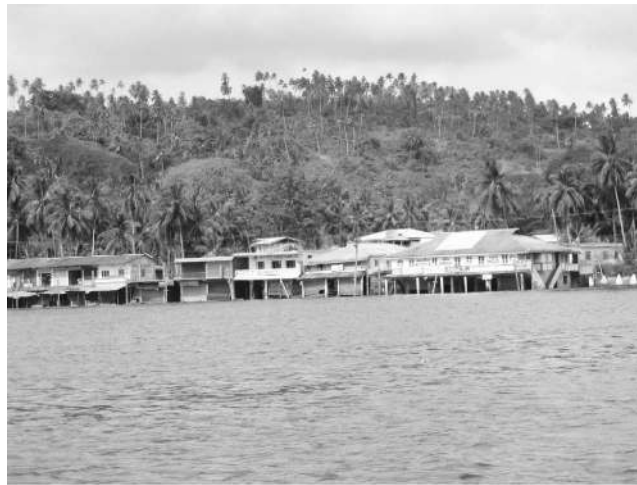
Figure 30. (a) Inundated shops in the Bamboo Flat area near Port Blair (photo: D. Rai), and (b) heavy RC drain covers were displaced from drains by the tsunami (photo: S. Jain).

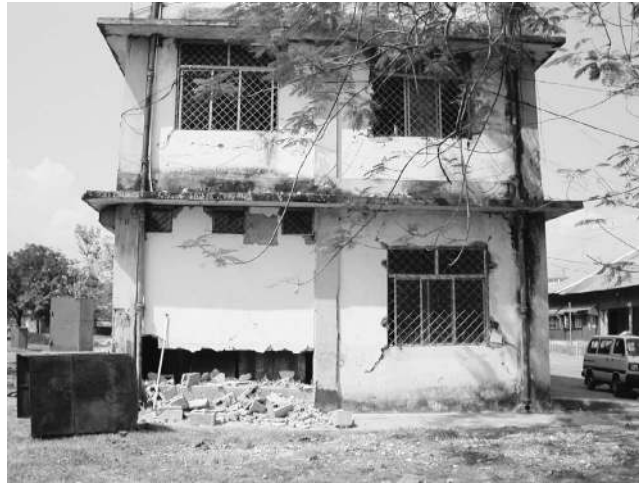
On the other hand, in the Andaman Islands, while tsunami-induced damage to the contents of buildings was significant, the fury of the waves was less and caused less tsunami-induced damage to the structure of the buildings themselves. For instance, in the Bamboo Flat area near Port Blair in South Andaman Island, the street-front shops were inundated because of land subsidence. The steel shutters of the shops were damaged, and the drainage covers were displaced (Figure 30). In some other buildings in the same region, the boundary walls collapsed. In the old dry dock in the marine jetty dry dock complex in Port Blair, the water pressure caused out-of-plane collapse of the masonry infill walls (Figure 31).

Figure 31. The old dry dock in the marine jetty dry dock complex was inundated in seawater after the event, and the masonry walls were damaged (photo: H. Kaushik).

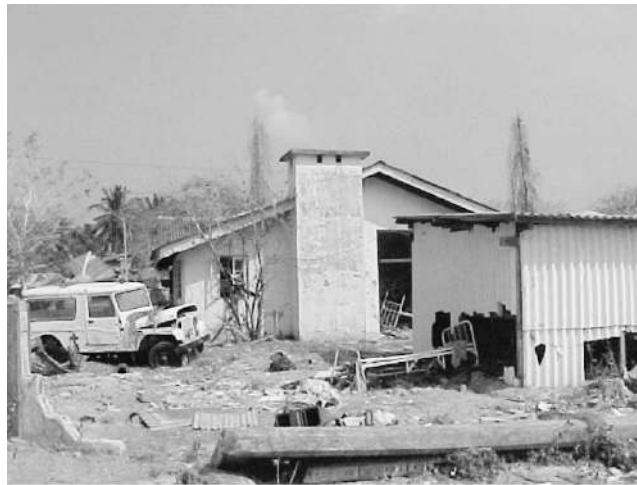
Because of the tsunami, civic administrators need to consider relocating the limited critical infrastructure, like hospitals, at higher elevations. At Hut Bay in Little Andaman Island, the hospital was about 500 m from the coast and sustained partial collapse during earthquake shaking and inundation (Figure 32). The partial collapse is attributable to the rusted structural steel building system that is many decades old; its main structural

members such as columns and roof trusses are corroded, and the connections are weakened. The loss of the hospital severely affected the postearthquake care of the survivors on the island.

Figure 32. A hospital unit at Hut Bay in Little Andaman Island that is several decades old: (a) steel beds were punctured through the asbestos vertical cladding during the tsunami, and (b) collapse of the front portion of the hospital due to ground shaking (photos: C. Murty).
