3rd International Symposium on Fatigue Design and Material Defects, FDMD 2017, 19-22  
September 2017, Lecco, Italy

## Damage Detection using Infrared Thermography in a Carbon-Flax Fiber Hybrid Composite

Raghu V Prakash<sup>a\*</sup>, Monalisha Maharana<sup>a</sup>

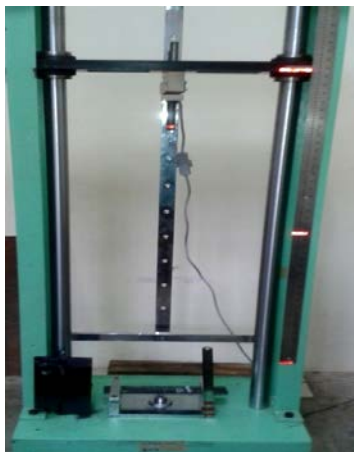
Fig. 3 – Drop Impact tester used for impacting specimens.

The tensile specimens were impacted with an energy of ~5 J (low velocity of ~1.4 m/s) using a Drop-Impact test set-up (Fig. 3). A 5.2 kgf hemispherical impact head, with a nominal diameter of 16 mm, was used to impact the specimen. The rectangular specimens were impacted with ~10 J input impact energy. These impacts were sufficient to impart a Barely Visible Impact Damage on the specimen (BVID).

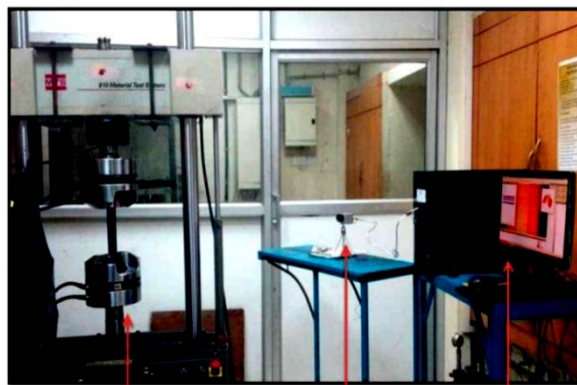
Fig. 4 – Infrared imaging and MTS 810 servo-hydraulic test system used for the experiments.

A Micro-Epsilon Infra-red (IR) camera (Model: TIM 160) was used to monitor the specimen response after it was heated using a halogen lamp for a time period of 20 s at different configurations, such as rear side heating (Transmission mode) and front side heating (Reflection mode). Figure 4 presents the photograph of experimental set-up. The cooling response in Transmission mode as well as in Reflection mode was obtained at both the impacted region and the non-impacted region of the specimen for the following conditions:

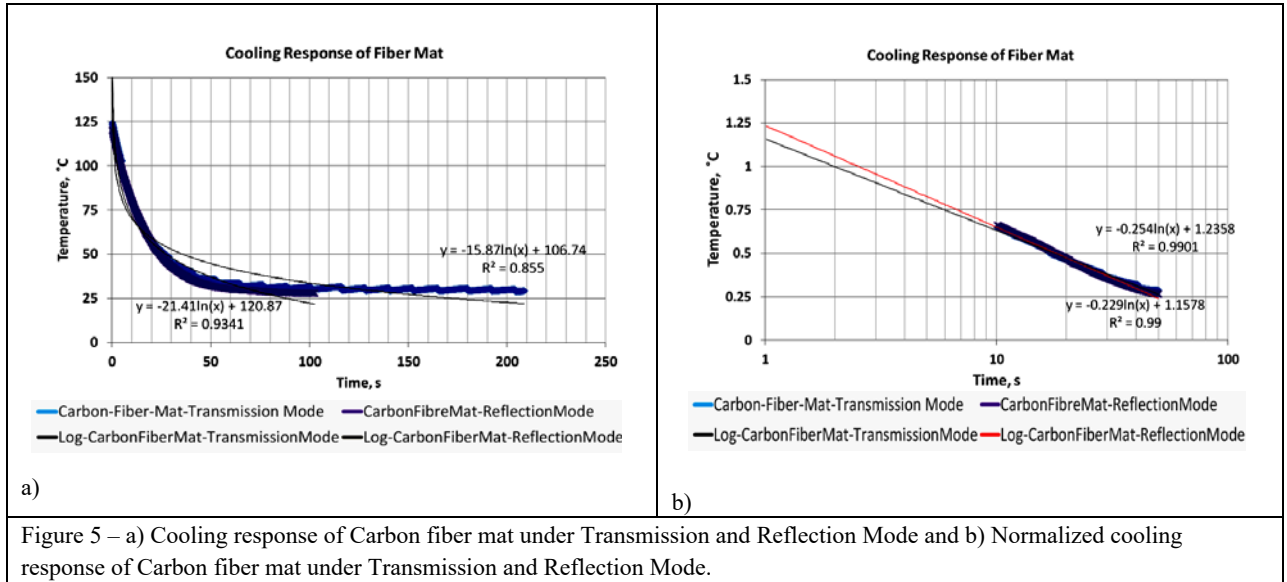
Figure 5 – a) Cooling response of Carbon fiber mat under Transmission and Reflection Mode and b) Normalized cooling response of Carbon fiber mat under Transmission and Reflection Mode.

Figure 5a presents the cooling response of carbon fiber mat in the reflection and transmission mode. A logarithmic fit of cooling response was made and it is noted that there is not a significant difference between the transmission mode and reflection mode of cooling for the Carbon fiber mat that was chosen for this study. Similar observation was made with respect to Flax fiber mat. As the temperature at the beginning of cooling response could not be held constant for all the cooling response trials, the temperature-time response was normalized with reference to the temperature at the start of cooling response and the normalized temperature-time response was used for fitting this function. The normalized temperature vs. time data plotted in log-linear graph is shown in Fig. 5b. The logarithmic constants do not show much of a difference between the transmission and reflection mode for the carbon fiber mat as well as for the natural fiber mat. However, one could note that the logarithmic fit is not exact; in an attempt to look into this aspect, the best fit response was sought and it was noted that a double exponential representation of temperature-time response showed the best fit. The temperature at any instant ( $T(t)$ ) is given by the following equation:

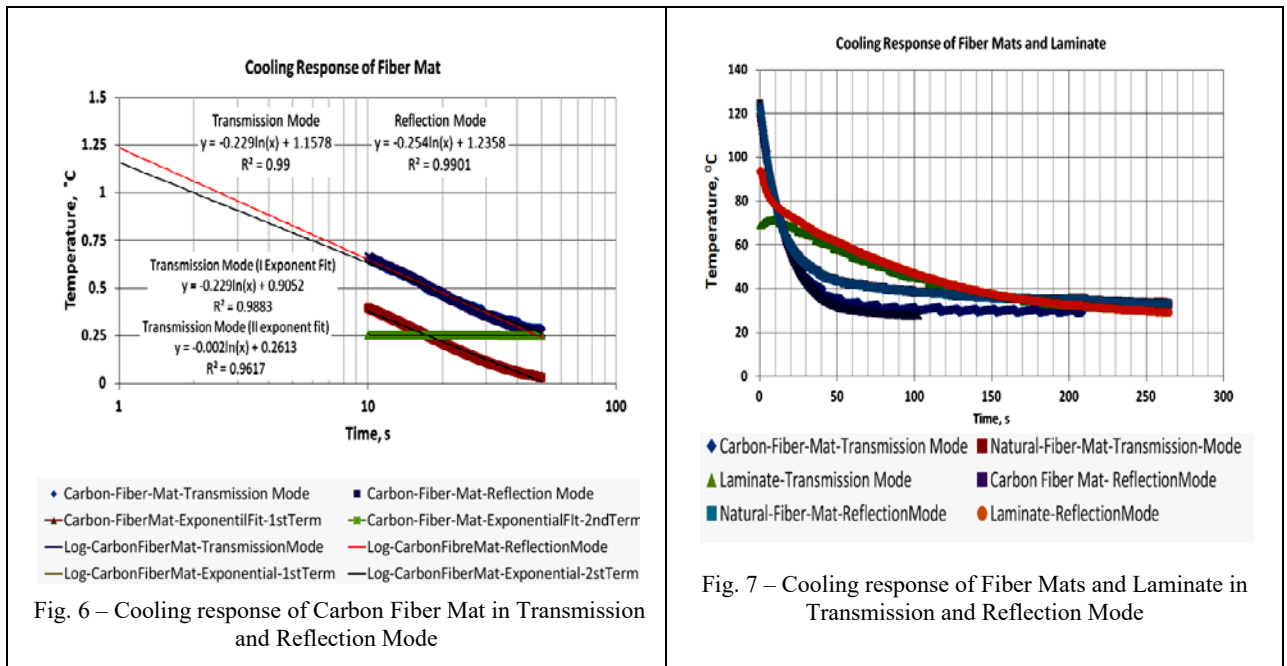
Fig. 6 – Cooling response of Carbon Fiber Mat in Transmission and Reflection Mode

Fig. 7 – Cooling response of Fiber Mats and Laminate in Transmission and Reflection Mode

Figure 6 presents the plot of temperature-time response with logarithmic fit for normalized data as well as data obtained through the two exponents fit for the carbon fiber mat. It can be noted that the slope of the first exponent term is almost the same as that of the logarithmic fit of base data and the second exponential term has a very small slope. It can be surmised that the first

term of exponential term represents the heat transfer from the front face of the specimen, while the second term represents the heat transfer from the rear side of the specimen upon removal of active heat source from the halogen lamp.

Figure 7 presents the cooling response of the two types of fiber mats used in this study as well as that of the finished laminate of 2.1 mm thickness. It is noted that in case of pristine laminate, the cooling response (in the normalized temperature format) is showing a difference between the transmission and reflection mode. The temperature appears to increase by a small amount in the transmission mode (up to a time period of about 8 seconds) and thereafter cools, whereas the slope of the cooling response in reflection mode is steep up to the same time period. A similar response was observed in our earlier work (Prakash and Sudevan, 2016) that dealt with woven Carbon fiber mat polymer composites. Table 2 presents the constants of exponential fit for the natural fiber and built-up laminate in transmission and reflection mode.

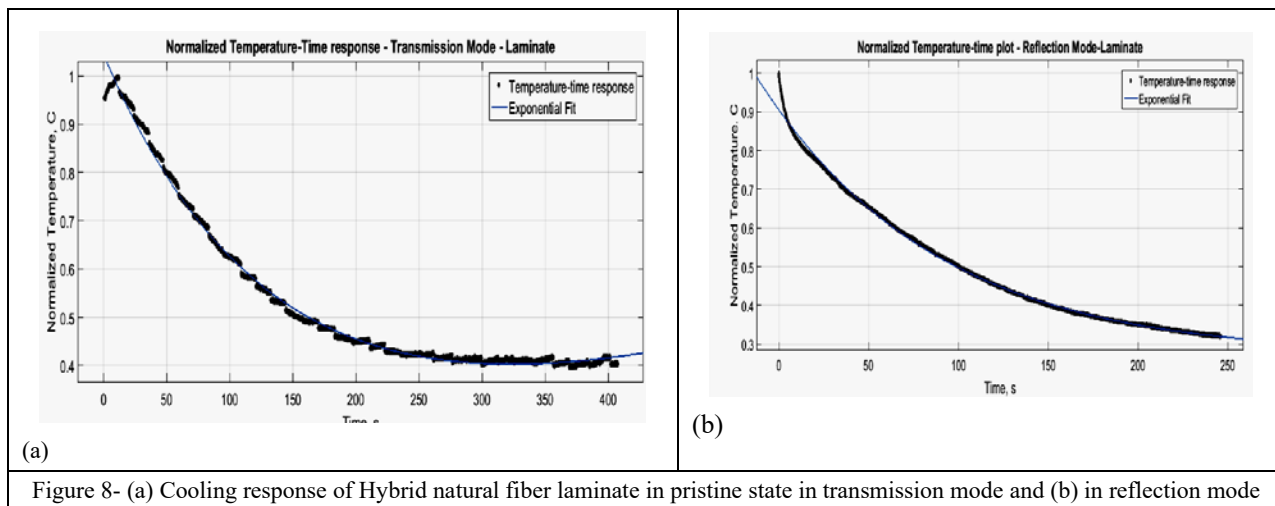
Figure 8- (a) Cooling response of Hybrid natural fiber laminate in pristine state in transmission mode and (b) in reflection mode

The cooling response of hybrid laminate alone is shown in Figure 8 for clarity of secondary heating and subsequent cooling response of laminate. It is noted that the temperature increases by a small amount in the transmission mode (up to a time period of about 8 seconds) and thereafter cools (Fig. 8a), whereas the slope of the cooling response in reflection mode is steep up to the time period of 8 seconds (Fig. 8b). The increase in temperature for the initial few seconds in transmission mode could be due to the initial heat transfer from the rear surface of specimen to the front surface by conduction mode of heat transfer and the same is captured by the front face of the infrared camera. Once the front surface temperature has stabilized, there is heat loss from the front and rear surface of the specimen. Possibly the heat transfer from the rear surface is the reason for the second exponential response of the specimen in the temperature-time response. In all subsequent experiments, cooling responses were monitored both in Transmission mode as well as in Reflection mode, but for the sake of brevity, transmission mode results alone will be presented in the later parts of this paper. In case of impacted specimens, there are two options: to have the impacted side facing the camera (or) have it facing behind the camera.

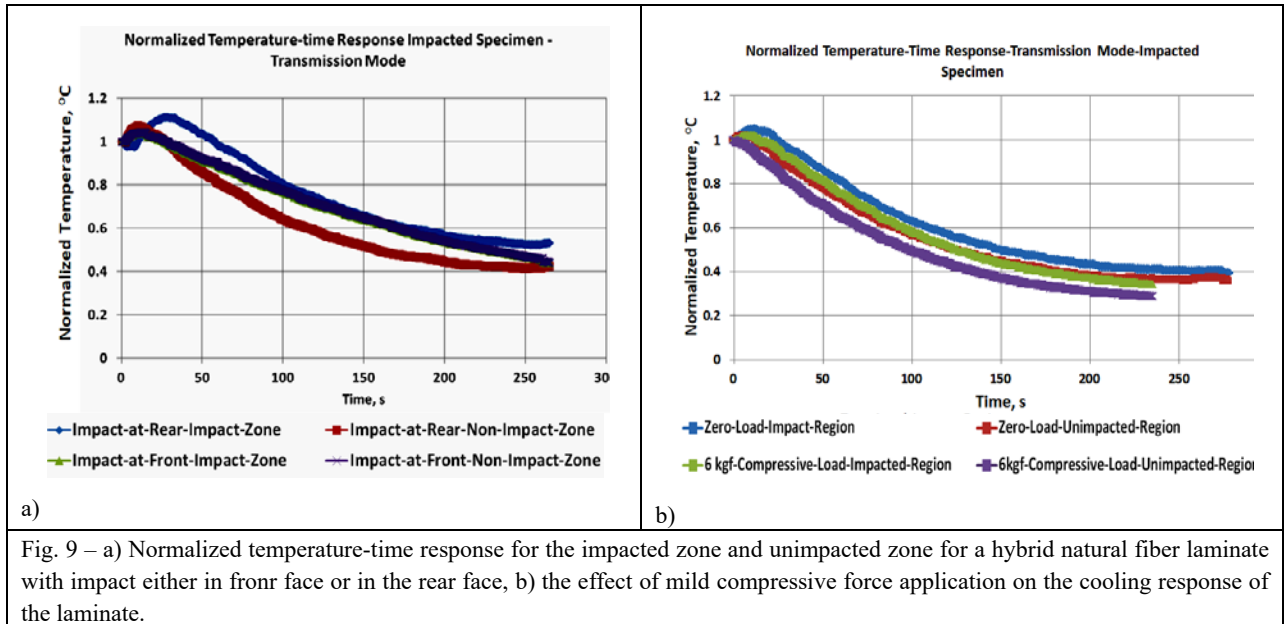
Figure 9a presents the normalized cooling response comparison under Transmission mode (rear heating) between the impacted region and non-impacted region of a 10 J impacted specimen. The impacted region was kept either in front of the IR camera or on the rear side of the IR camera. It is noted that the difference between impacted and non-impacted region can be seen clearly when the impacted region is kept on the rear side of the specimen. A time delay was observed for the peak temperature to be attained in the impacted region and this also results in a shift along the time axis in the cooling response as a function of time. The increase in magnitude of peak temperature and delayed cooling response could be due to the trapping of heat inside the impact region which gets released after a time delay during cooling response. Figure 9b presents the normalized cooling response for the case of specimen under zero load conditions and with mild compressive load (6 kgf compressive loads). It can be noted that the application of compressive load did not significantly alter the cooling response to aid damage detection. Perhaps, an

application of a mild tensile load could have resulted in change in cooling response, as was found in our earlier studies (Prakash and Sudevan, 2016).

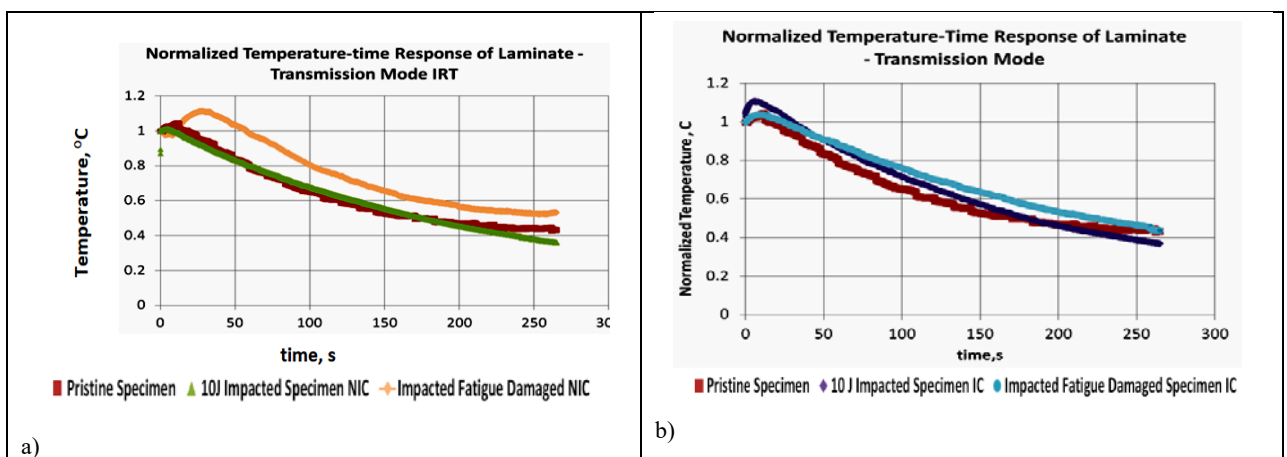
Figure 10a presents the cooling response in the transmission mode for a pristine, 10 J impacted laminate and 5 J impacted and subsequently fatigue cycled laminate. The impact damaged side was kept close to the heating source (i.e. impact side was not facing the IR camera). As seen in the figure, there is an initial heating in the specimen in transmission mode before cooling starts. The extent of time it took for heating from initial condition (also termed as time delay for cooling response) was higher in case of impact damaged and fatigue cycled specimen. This could be because of extensive de-lamination that had taken place in the fatigue damaged specimen compared to impacted specimen. Figure 10b presents the cooling response for the same set of specimens where the impact side was facing the IR camera. The time delay for the commencement of cooling response in this case was much less compared to the impact side not facing the camera.

It would imply that it would be appropriate to use impact side not facing the camera (i.e. rear side) and heat the specimen in transmission mode (i.e. from rear side) to obtain clear distinction in terms of cooling response for damaged FRP specimens. The exponential constants in both these cases provide a confirmation of the same.
