Performance of Structures in the Andaman and Nicobar Islands (India) during the December 2004 Great Sumatra Earthquake and Indian Ocean Tsunami

C.V.R. Murty,^{a)} M.EERI, Durgesh C. Rai,^{a)} M.EERI, Sudhir K. Jain,^{a)} M.EERI, Hemant B. Kaushik,^{a)} Goutam Mondal,^{a)} and Suresh R. Dash^{a)}

The damage sustained by buildings and structures in the Andaman and Nicobar islands area was due to earthquake shaking and/or giant tsunami waves. While damage on Little Andaman Island and all the Nicobar Islands was predominantly tsunami-related, damage on islands north of Little Andaman Island was primarily due to earthquake shaking even though tsunami waves and high tides were also a concern. In general, the building stock consists of a large number of traditional and non-engineered structures. Many traditional structures are made of wood, and they performed well under the intensity-VII earthquake shaking sustained along the islands. However, a number of new reinforced concrete (RC) structures suffered severe damage or even collapse. Also, extensive damage occurred to the coastal and harbor structures in the Andaman and Nicobar islands. [DOI: 10.1193/1.2206122]

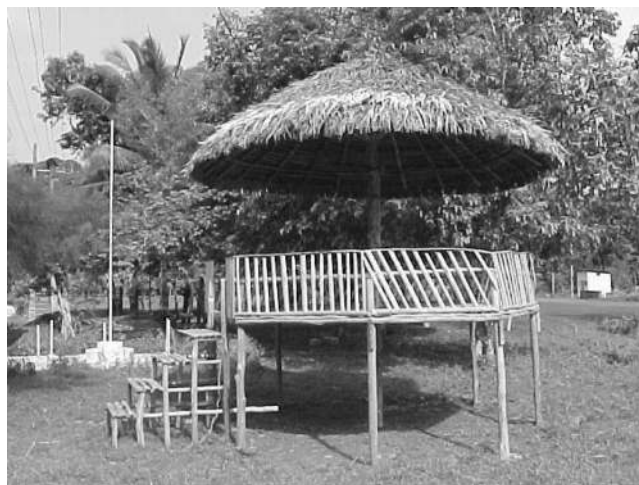
The traditional structures built by the native islanders also demonstrate an understanding of the effects of earthquake shaking on buildings. The huts made by the Sompnen tribe have a regular configuration and light mass (Figure 10). The 2-m-diameter circular structure on eight axisymmetrically placed 75-mm-diameter posts is built at an elevation of 1.4 m. The use of local material such as bamboo and thatch makes these structures the first choice for housing among the native population. Unfortunately, for many reasons, more recent migrants to the islands have chosen not to adopt these materials. These reasons include the prohibition against the use of wood in construction and

Figure 10. Typical hut built by the Sompian tribe living in the islands. This is a prototype hut built in the Army land area in Campbell Bay in Great Nicobar Island (photo: C. Murty).
