Repair of through thickness corrosion/leaking defects in corroded pipelines using Fiber Reinforced Polymer overwrap

P Nitheesh Kumar¹, Vishwas Chandra Khan¹, G Balaganesan^{2,*}, A K Pradhan¹ and M S Sivakumar²

Abstract. The present study is concerned with the repair of through thickness corrosion or leaking defects in metallic pipelines using a commercially available metallic seal and glass/epoxy composite. Pipe specimens are made with three different types of most commonly occurring through thickness corrosion/leaking defects. The metallic seal is applied over the through thickness corrosion/leaking defect and it is reinforced with glass/epoxy composite overwrap. The main objective of the metallic seal is to arrest the leak at live pressure. After reinforcing the metallic seal with glass/epoxy composite overwrap, the repaired composite wrap is able to sustain high pressures. Burst test is performed for different configurations of metallic seal and optimum configuration of metallic seal is determined. The optimum configurations of metallic seal for three different types of through thickness corrosion/leaking defects are further reinforced with glass/epoxy composite wrap and expe

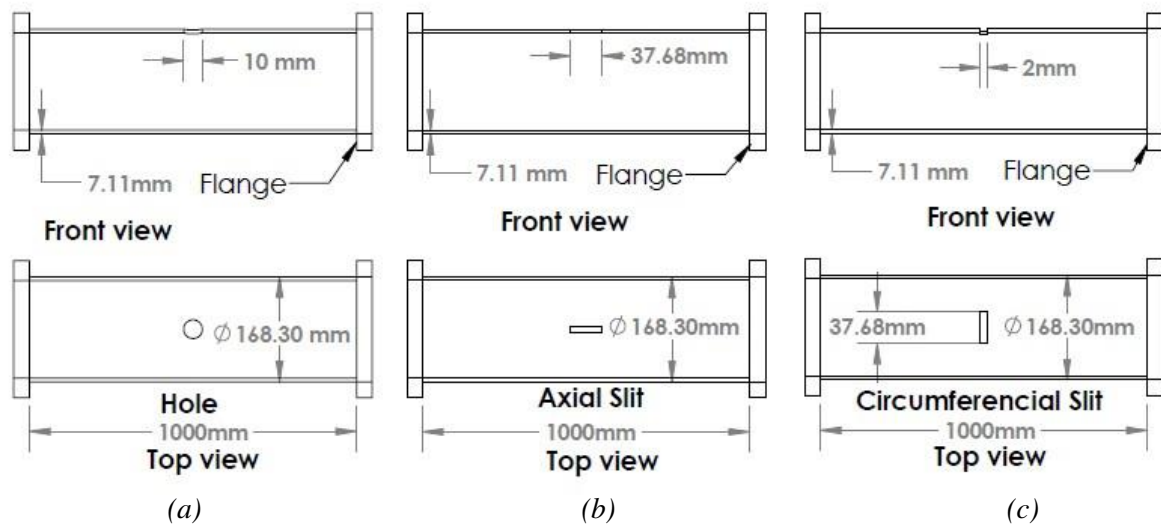
Figure 1. Pipe specimen with (a) defect as a hole (b) defect as slot in longitudinal direction (c) defect as circumferential slot

API 5L X65 pipe specimens which have a length of 1000mm and outer diameter of 168.3mm and thickness of 7.11mm are used in the experimentation. Three pipe specimens, one with 10mm circular defect and one with 2mm circumferential slot defect and the other with 2mm axial slot defect is machined using CNC milling at the centre of the pipe section with all the three having same surface defect area of 78.54mm². The test pipe specimen with circular defect, circumferential slot defect and axial slot defect are in shown figure 1(a), (b) and (c) respectively. The repair is done in two phases. In the first phase of the repair, the metallic seal in the form of paste is applied over the defect in dry condition and certain amount of pressure is exerted onto to it so that it forms a plug in the defect hole and the interfacial bonding of the metallic seal with the test specimen is experimented with three different shapes of circular, elliptical and round cornered rectangle forms having same area of 6283 mm². The repair bonding paste (M-Seal Phataphat) is firmly held in place by applying pressure using a rubber tourniquet so that it forms a plug in the defect hole. The metallic seal is allowed to cure for three hours and burst test is conducted to find out the failure pressure. Prior to applying the metallic

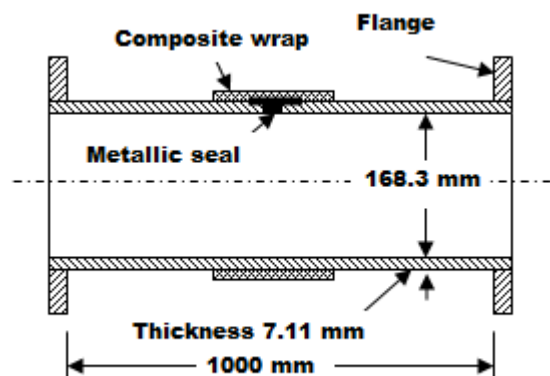
Figure 2. Schematic arrangement of pipe after repair with metallic seal and composite wrap

seal over the defect, the pipe surface near the defect area is cleaned and made rough to have better interfacial bonding. The best result of the first phase i.e., the shape with which highest failure pressure is achieved goes through the second phase of the repair where the first phase of repair is done and then it is reinforced by wrapping four layers of bi-directional (woven roving) glass fiber mat of 560 gsm wetting with epoxy (Araldite LY556, Hardener HY951). Schematic arrangement of test pipe specimen after second phase of the repair is shown in figure 2. The wrap length and the axial width of the wrap are calculated as per ISO 24817 standards [7].

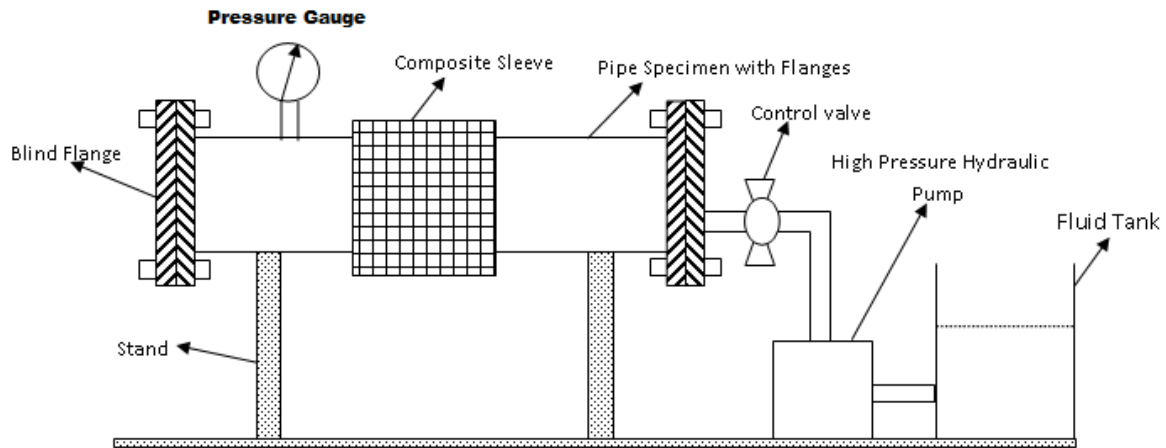
Figure 3. Schematic arrangement of pipe pressure testing set-up

Burst test of the test pipe specimens is conducted at room temperature with the defect repaired with metallic seal with and without composite wrapping. A high-pressure hydro pump is used to pressurize the fluid in the pipe section. The fluid used for conducting the experiment is water soluble coolant oil mixed with water. Strain gauges are mounted on the wrap in axial and hoop directions to measure the strain induced while performing the test and its output is fed to a computer using a data acquisition

system and a strain module. The test pipe specimen is pressurized until failure occurs. The layout of the burst test setup with the repaired pipe specimen is shown in figure 3.

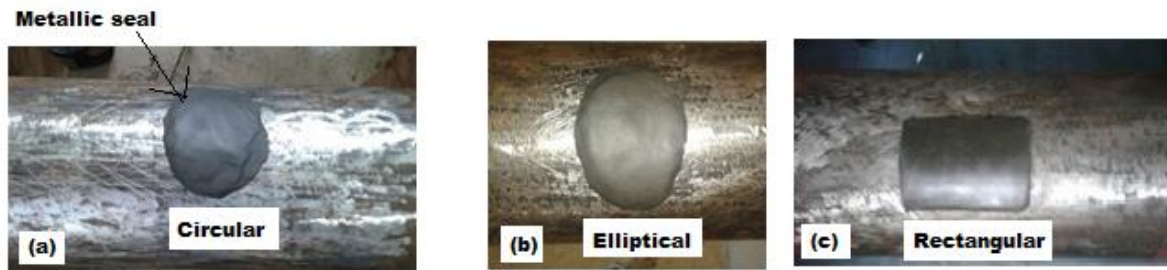
Figure 4. First phases repaired using metallic seal specimens of Circular defect with different configurations (a) Circular (b) Elliptical (c) rectangle

The test pipe specimen with circular defect of 10mm diameter is repaired with first phase repair using metallic seal in three different configurations circular, elliptical, round ended rectangle. The first phase repaired specimens of circular defect are shown in figure 4. Burst test is performed and all the configurations failed radially with elliptical configuration having the maximum failure pressure of 2.5MPa. So, the test pipe specimen with circular defect is repaired with metallic seal by applying metallic seal in elliptical configuration and is firmly held in place by applying pressure using a rubber tourniquet so that it forms a plug in the defect hole. The metallic seal is allowed to cure for three hours

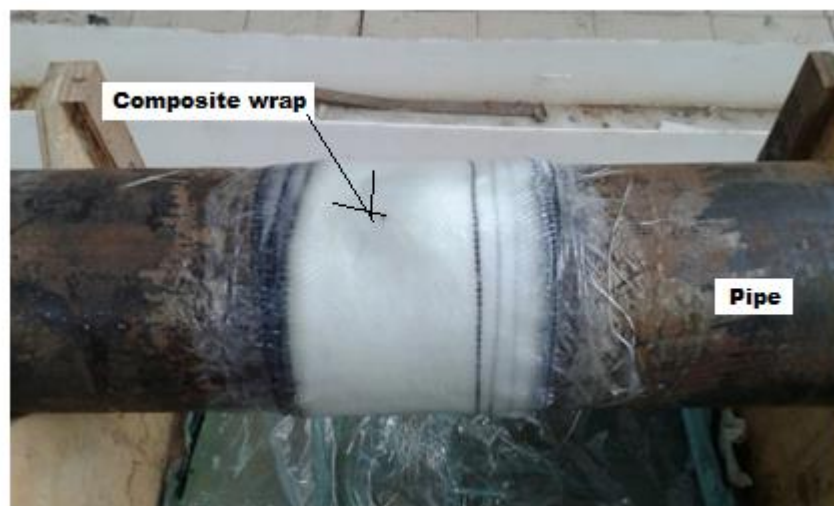
Figure 5. Circular defect repaired with elliptical configuration of metallic seal further reinforced with composite sleeve

and then it is reinforced by wrapping four layers of bi-directional (woven roving) glass fiber mat of 560 gsm wetting with epoxy (Araldite LY556, Hardener HY951). The test pipe specimen with circular defect after second phase repair is shown in figure 5. Burst test is performed and the repair failed at 12.5 MPa. The results of the burst test are tabulated in Table 1.

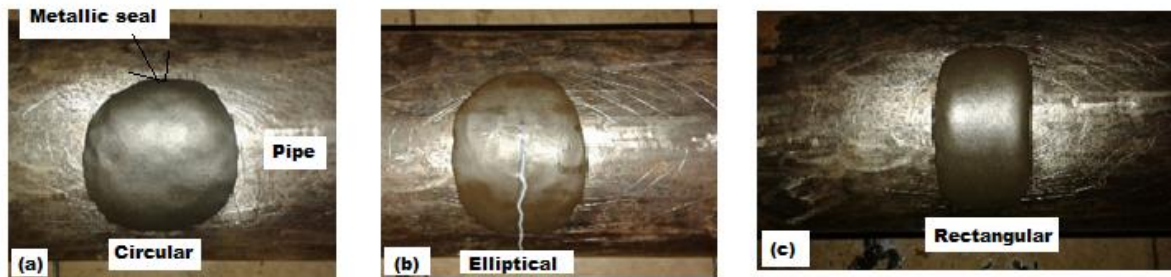
Figure 6. First phase repaired specimens of circumferential slot defect with different configurations (a) Circular (b) Elliptical (c) Rectangle

The test pipe specimen with circumferential slot defect which is 37.68mm long, 2mm wide and oriented in circumferential direction is repaired with first phase repair using metallic seal in three different configurations circular, elliptical, round ended rectangle. The first phase repaired specimens of circumferential slot defect are shown in figure 6. Burst test is performed and all the configurations failed radially with elliptical configuration having the maximum failure pressure of 4MPa. So, the test pipe specimen with circumferential slot defect is repaired with metallic seal by applying metallic seal in elliptical configuration and is firmly held in place by applying pressure using a rubber tourniquet so that it forms a plug in the defect hole. The metallic seal is allowed to cure for three hours and then it is reinforced by wrapping four layers of bi-directional (woven roving) glass fiber mat of 560 gsm wetting with epoxy (Araldite LY556, Hardener HY951). The test pipe specimen with circumferential slot defect after second phase repair is shown in figure 7. Burst test is performed and the repair failed at 15 MPa. The results of the burst test are tabulated in Table 1.

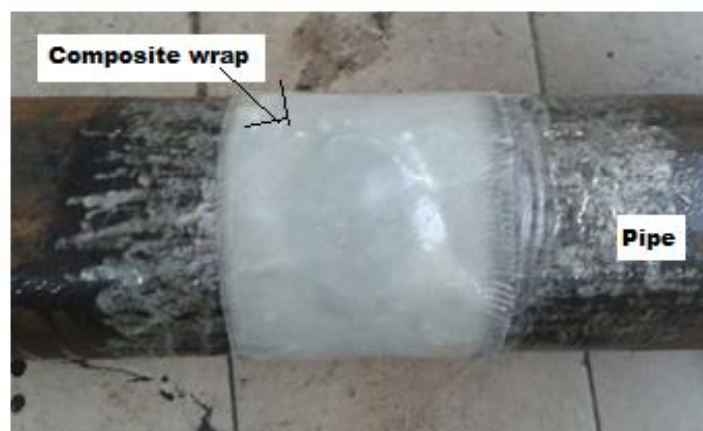
Figure 7. Circumferential slot defect repaired with elliptical configuration of metallic seal further reinforced with composite sleeve.

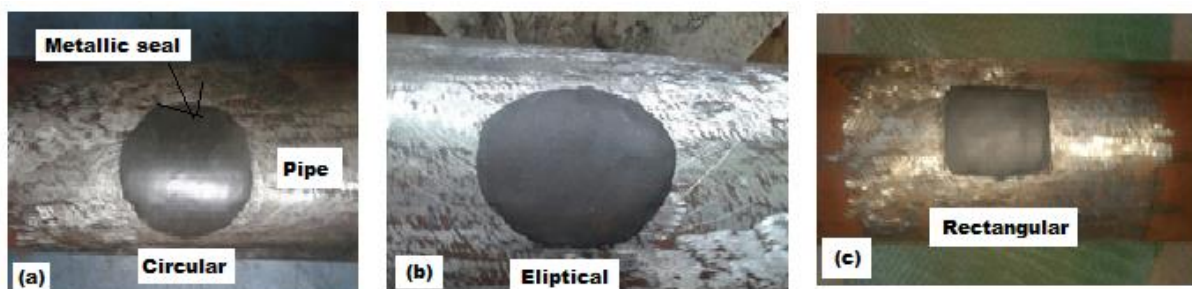
Figure 8. First phase repaired specimens of axial slot defect with different configurations (a) Circular (b) Elliptical (c) Round ended rectangle

The test pipe specimen with axial slot defect which is 37.68mm long, 2mm wide and oriented in axial direction is repaired with first phase repair using metallic seal in three different configurations circular, elliptical, round ended rectangle. The first phase repaired specimens of axial slot defect are shown in figure 8. Burst test is performed and all the configurations failed radially with elliptical configuration having the maximum failure pressure of 3.5MPa. So, the test pipe specimen with axial slot defect is repaired with metallic seal by applying metallic seal in elliptical configuration and is firmly held in place by applying pressure using a rubber tourniquet so that it forms a plug in the defect hole. The metallic seal is allowed to cure for three hours and then it is reinforced by wrapping four layers of bi-directional (woven roven) glass fiber mat of 560 gsm wetting with epoxy (Araldite LY556, Hardener HY951). The test pipe specimen with axial slot defect after second phase repair is shown in figure 9. Burst test is performed and the repair failed at 13.5 MPa. The results of the burst test are tabulated in Table 1.

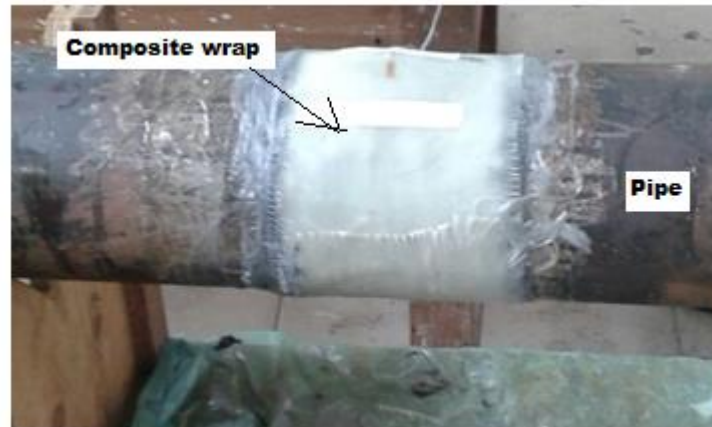
Figure 9. Axial slot defect repaired with elliptical configuration of metallic seal further reinforced with composite sleeve.

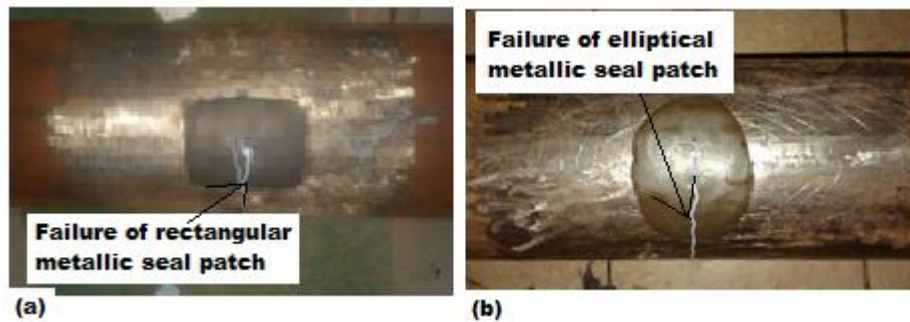
Figure 10. Metallic seal failing radially in (a) Rectangular (b) Elliptical configurations

The metallic seal used in the above experiments had very good interfacial bonding. After the first phase repair is done, burst test was performed. All the repair configurations failed radially i.e., there was no sign of leak from the edges of the repair. No debonding was observed in all the three different configurations after performing the burst test. It suggests that the metallic seal has good interfacial bonding with the steel substrate when compared to neat epoxy (Araldite LY556, Hardener HY951). Tensile strength and lap shear strength/adhesive strength of the metallic seal are experimentally found according to ASTM D638 [10] and ASTM D3163 [11] respectively. The maximum tensile stress of metallic seal is 20.24 MPa and lap shear strength of metallic seal is 34.58 MPa. The first phase repair with metallic seal failing radially is shown in figure. 10
