Investigations of surface characterization of silicone rubber due to tracking phenomena under a.c. and d.c. voltages

Abstract. In the present work, tracking phenomena has been studied with silicone rubber material under the a.c. and d.c. voltages following IEC-587 standards. The surface condition of the tracked zone was analysed using wide angle X-ray diffraction (WAXD) and thermogravimetric differential thermal analysis (TG-DTA) studies. The tracking time was different for a.c. and d.c. voltages.

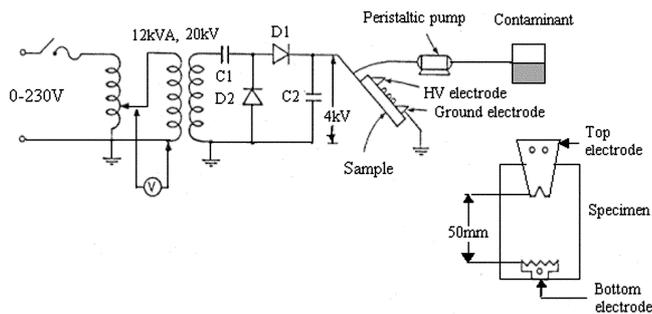
Figure 1. Experimental setup for tracking test (IEC 587).

The schematic diagram of the experimental setup and the electrode configuration used in the present work are shown

in figure 1. The present work has been carried out for the a.c. and d.c. voltages, following the IEC-587 (1984) test method. The specimen used in the present work was silicone rubber insulation with ATH material as filler. The a.c. and d.c. voltages were fixed at 4.5 and 4 kV, respectively. The contaminant used in the present study was 0.1 N NH₄Cl solution. The flow rate used here was 0.6 ml/min and other flow rates could be achieved using the peristaltic pump. The times to failure due to tracking arrived at once the arc inception took place near the bottom electrode and crossed two third of the gap or once the bulk volume of the material was totally eroded otherwise the process lasted for 6 h and the experiment was properly terminated.

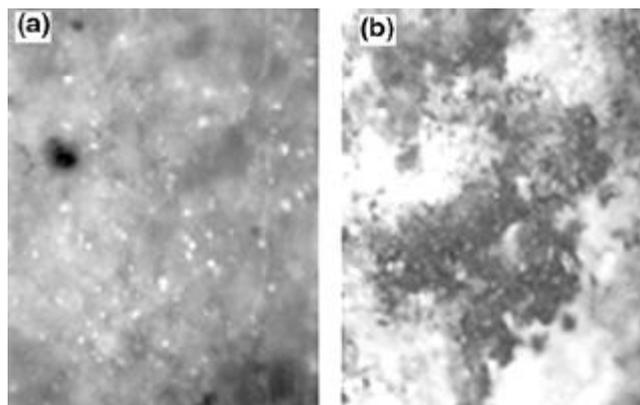
Figure 3. Optical photographs of (a) virgin and (b) tracked zone.

Figure 3 shows the optical picture of the surface of the virgin and the tracked zone of the specimen. It is clear from the figure that tracking is a localized carbonization process. The variation in the tracking time of silicone rubber specimen under a.c. and d.c. voltages with NH₄Cl as contaminant, at different flow rates, is as shown in figure 4. It is observed that under a.c. voltages, no specimen failed in the specified time duration.

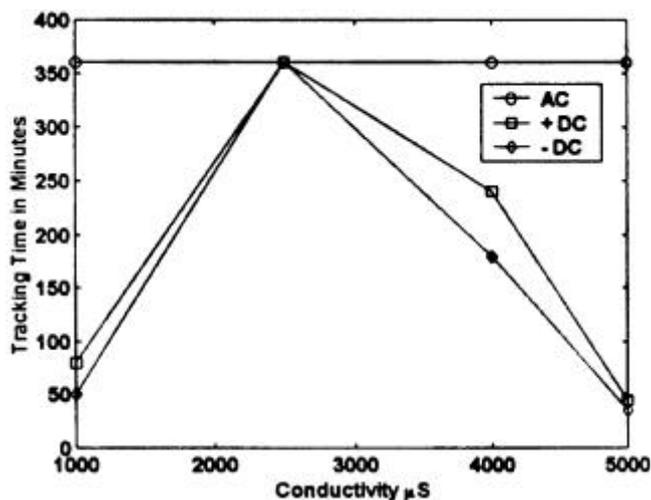
Figure 2. Variation in tracking time of silicone rubber material with different conductivity of the contaminant under different voltages.

The variation in tracking time of the virgin silicone rubber specimen under a.c. and d.c. voltages with NH₄Cl as the contaminant, at different conductivity levels, is shown in figure 2. It is observed that no failure of specimen occurred due to tracking under the a.c. voltages. Under the positive d.c. voltage, it is observed that the tracking is high compared to negative d.c. voltage. Table 1 shows the variation in tracking time of the silicone rubber insulation (aged under different conditions) under a.c. and d.c. voltages with NH₄Cl as the contaminant (of 2500 µs). It observed no tracking under a.c. voltage and the samples failed due to tracking under d.c. voltages.

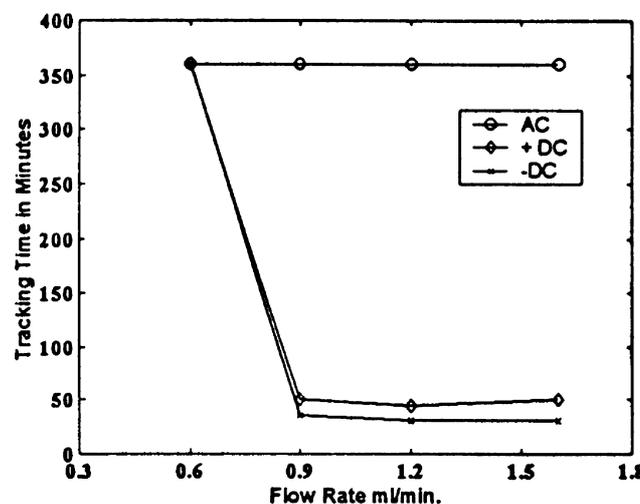
Figure 4. Variation in tracking time of silicone rubber material with different flow rates of the contaminant under different voltages.

Under d.c. voltages, a drastic reduction in tracking time is observed.

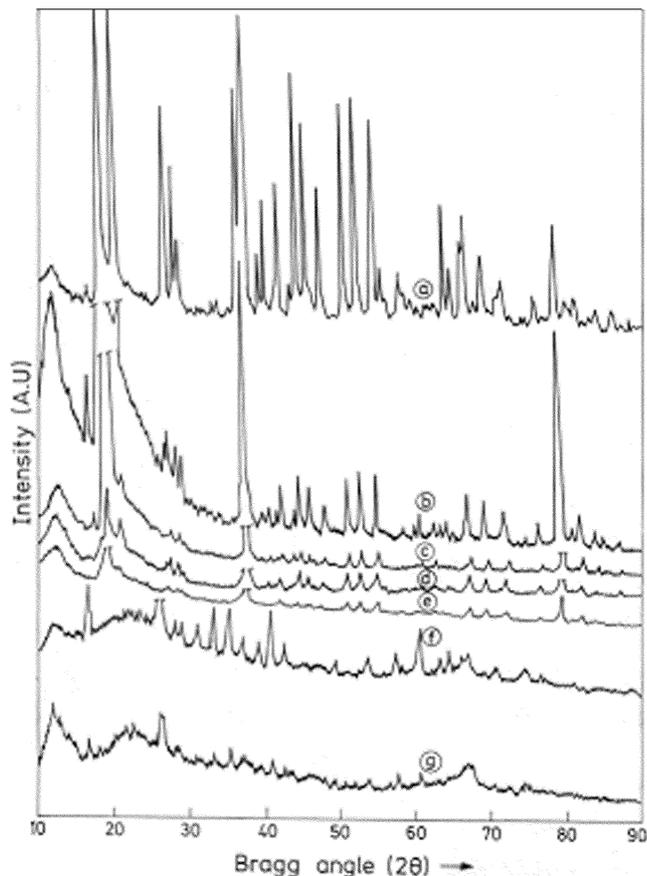
Figure 5. WAXD spectra: (a) ATH material, (b) virgin silicone rubber, (c) aged in nitric acid, (d) water aged, (e) thermal aged, (f) black carbon residue and (g) white carbon residue.

Figure 5 shows WAXD spectra of silicone rubber insulation material (aged under different conditions) used in the present work. The broad peak in the range 10–15° indicating that the material is silicone polymer and the peak near 20° is due to the ATH filler in the material. The peaks above 20° match with the peaks of the crystalline ATH filler material. WAXD spectra were also obtained for the residues obtained during tracking process. At the tip of tracked zone only white carbon is observed and in the body of the tracked zone black carbon is noticed. The presence of white carbon indicates that the temperature near the tip of tracked zone has raised to 1000°C, which leads to the tracking process (Kumagai *et al* 1998).

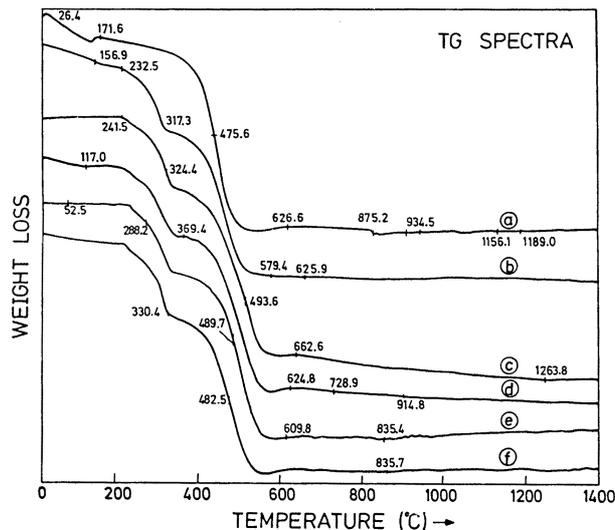
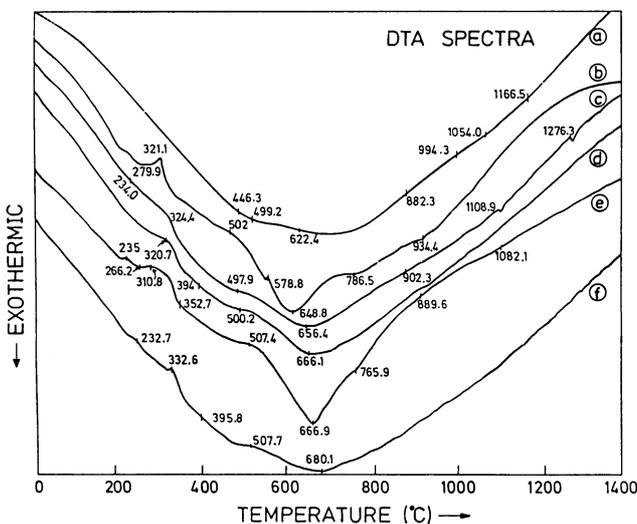
Figure 6. TG-DTA spectra of silicone rubber: (a) tracked surface, (b) samples aged in nitric acid, (c) sample dipped in hexane, (d) thermal aged sample, (e) virgin sample and (f) water aged sample.

Figure 6 shows TG and DTA spectra of silicone rubber insulation aged under different conditions. The TG curve shows gradual weight loss between 200 and 550°C for

the virgin sample and for the aged samples. The DTA curve indicates a large endothermic dent at the temperature around 660°C indicating that the thermal decomposition of the silicone rubber becomes more active above 660°C. Comparing the DTA spectra of virgin and the tracked surface zone, the characteristic exothermic peaks observed at 235°, 310° and at 507°C are altered in the tracked zone indicating variation in the surface condition of the tracked zone material.
